MARYLAND HISTORICAL TRUST DETERMINATION OF ELIGIBILITY FORM

DETERMINATION OF ELIC	GIBILITY FORM no
roperty Name: Williams House	Inventory Number: HO-563
Address: 13110 Greenberry Lane	Historic district: yes X no
City: Clarksville Zip Code: 21029	County: Frederick
USGS Quadrangle(s): Clarksville	
Property Owner: Robert B. Williams et al.	Tax Account ID Number: 05-372216
Tax Map Parcel Number(s): 48 Tax Ma	p Number: 28
Project: MD 32 at Linden Church Road	Agency: Maryland State Highway Administration
Agency Prepared By: Maryland State Highway	
Preparer's Name: Melissa Blair	Date Prepared: 12/15/2009
Documentation is presented in: MIHP HO-563	
Preparer's Eligibility Recommendation: X Eligibility recomm	nended Eligibility not recommended
Criteria: X A B X C D Considerations: A	BCDEFG
Complete if the property is a contributing or non-contributing	resource to a NR district/property:
Name of the District/Property:	77 NO. 17
Inventory Number: Eligible:	yes Listed: yes
ite visit by MHT Staff yes X no Name:	Date:

HO-563 Williams House Howard County USGS Clarksville Quadrangle

INVENTORY FORM FOR STATE HISTORIC SITES SURVEY

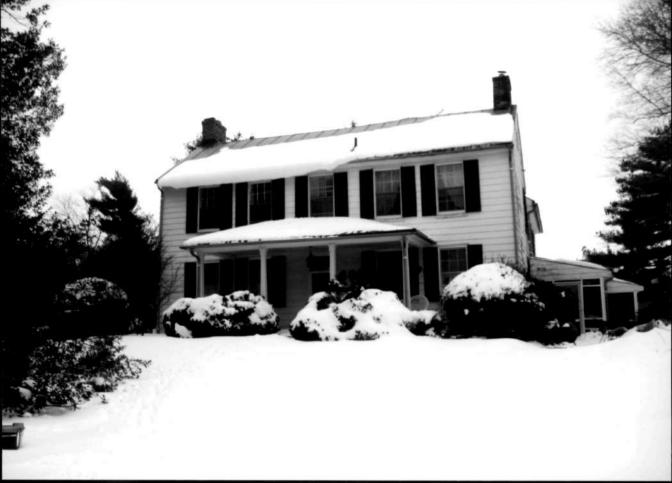
HO-563 Williams Hase Clarksville vicinity Howard Conty M. Blair Dec. 2009 MD SHPO East Elevation, view west Photo 1 of 17 HO-0563_2009-12-22_01.fif

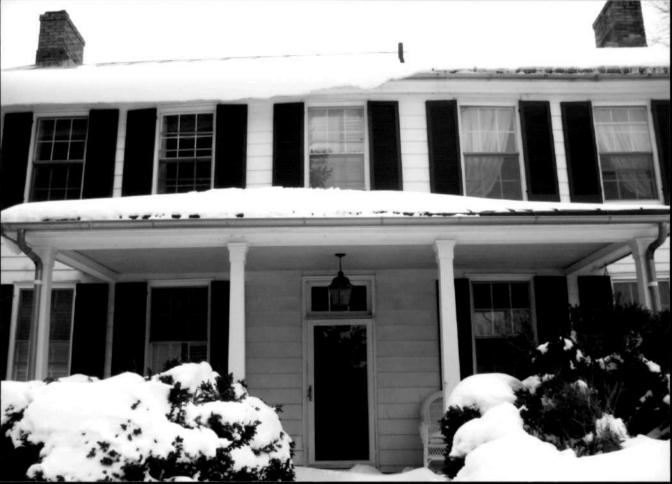
HO-563 Williams Hase Clorksville vicinity Howard Canty M. Blowir Dec. 2009 MD SHPO Frant Entrance, view west Photo 2 of 17 HO-0563_2009-12-22_02.tif

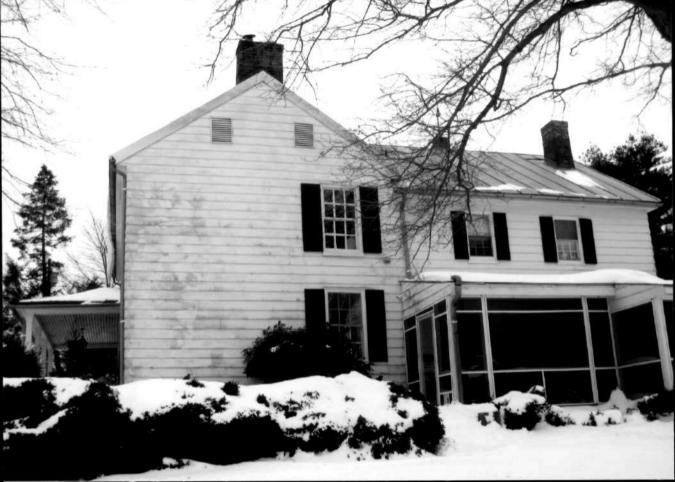
HO-563 Williams Hase Clarks ville vicinity Howard Carry M. Blair Dec. 2009 MD STIPO North Elevation, new south Photo 3 of 17 HO-0563_2009-12-22_03. fif

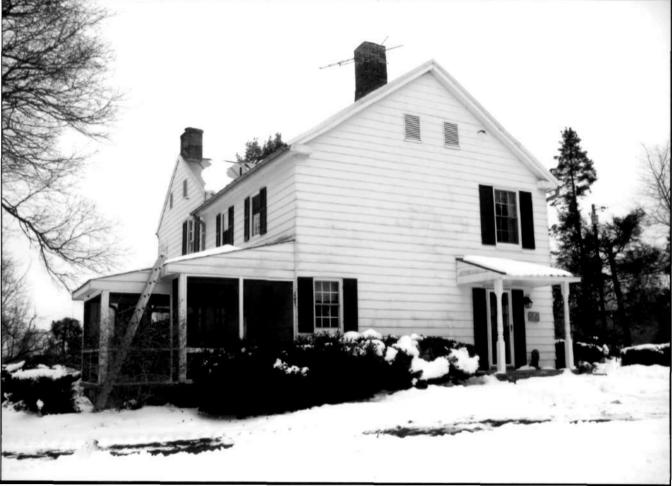
HO-563 Williams Hase Clarkeville vicinity Haverd Conty M. Blair Dec. 2009 MD SHPO North and West Elevations, view southeast Photo 4cf 17 HO-0563_2009-12-22_04, Hif

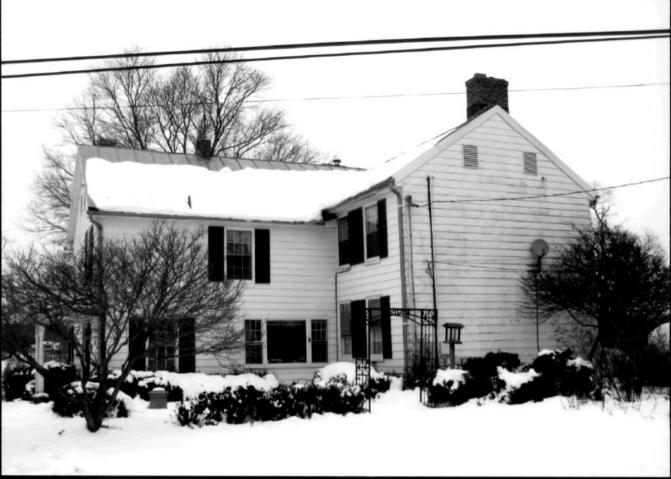
HO-563 Williams Hase Clarksville vicinity Havard Conty M. Blair Dec. 2009 MD SHPO Sath Elevation, view routh Photo Sof 17 Ho-0563_2009-12-22_05.tif

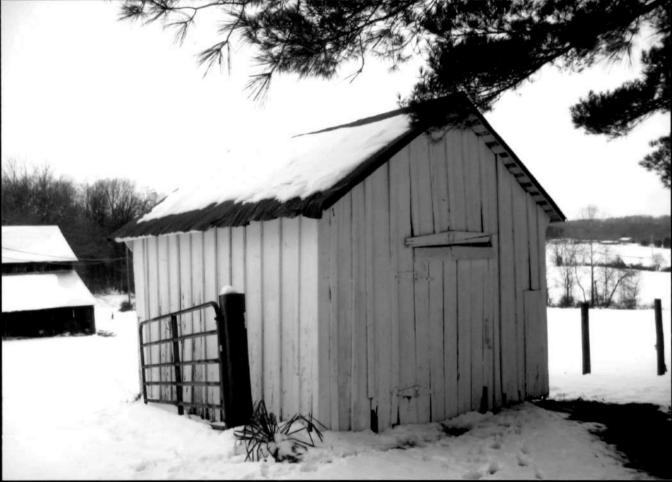
HO-563 Williams House agreenille vicinity Havard County M. Blair Dec. 7009 MD SHIPO Smoke hase, view northwest Photo 6 of 17 HO-0563_2009-12-17_06.tif

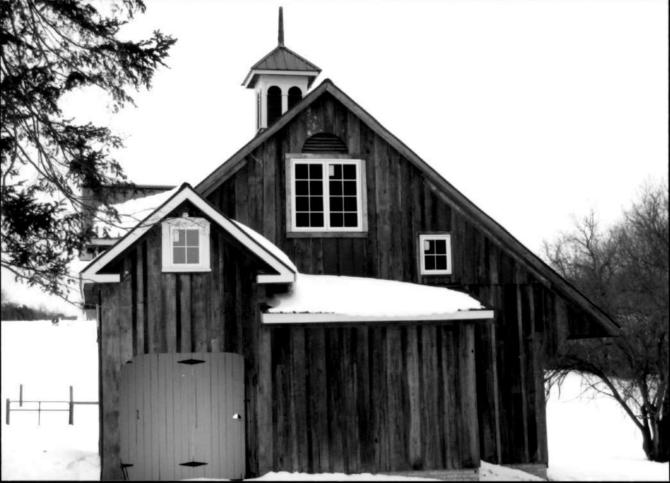
410-563 Williams House Clarksville vicinty Howard Carty M. Blair Dec. 2009 MD SHPO Carriage House, view south Photo 7 & 17 HO-0563_2009-12-22_07. +if

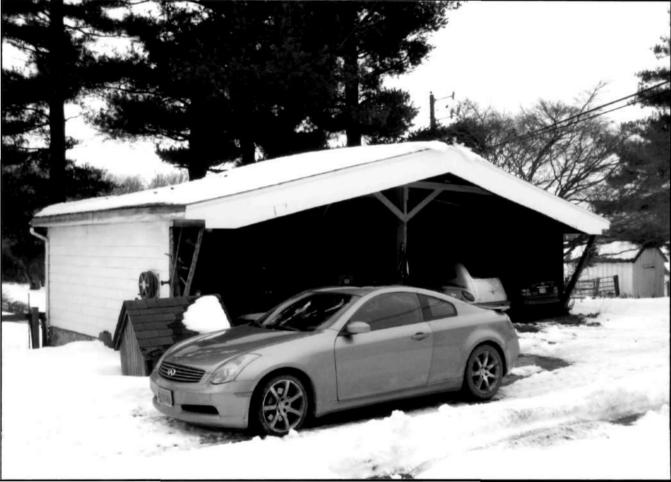
40-563 Williams Hase Clarksville Vicinity Howard Conty M. Blair Dec. 2009 MD SHPO Shed, vica northwest Photo 8 of 17 HO-0563_2009-12-22_08.tif

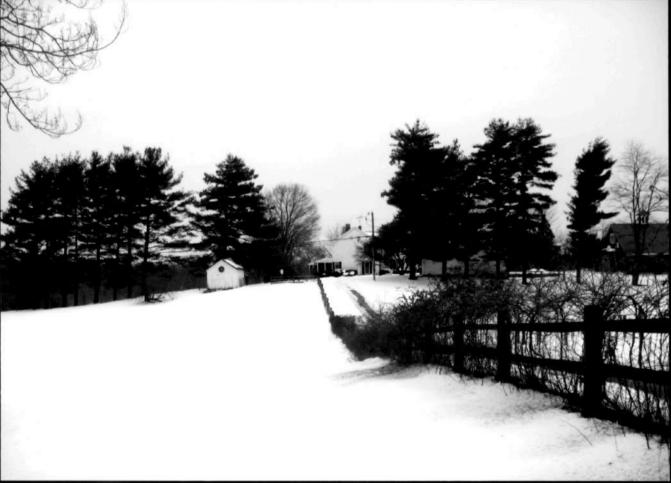
HO-563 Williams Hase arterille vicinity Howard Conty M. Blair Dec. 2009 MDSHPO Formstead View view East Photo 9 of 17 HO-0563_ 2009-12-22_09-Hif

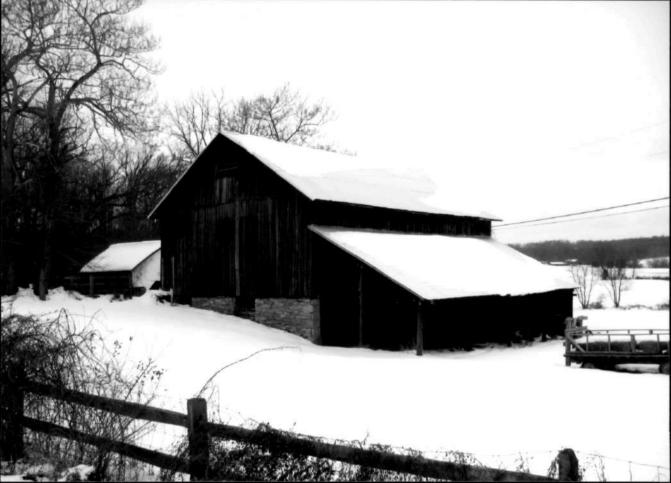
46-563 Williams Hase anterille vicinity Howard Courty M. Blair Dec. 2009 MD SHPO Bank Barn South and Gast Elevations, view northwest Photo 10 & 17 HO-0563_2009-12-22_10.HF

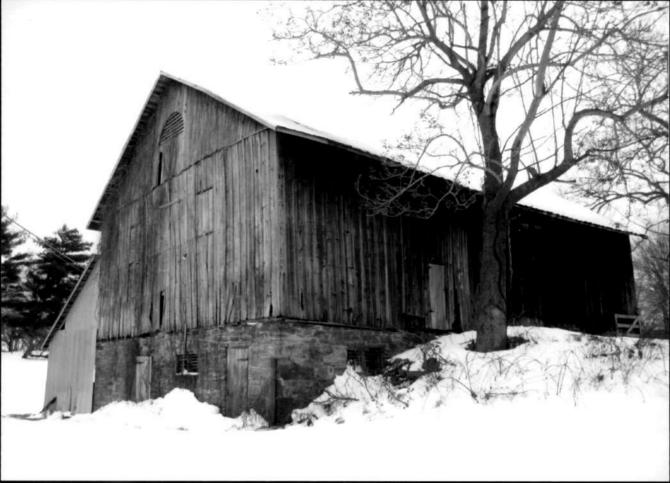
HO-563 Williams Hase acksille incinity Havard Carty M. Blair Dec. 2009 MD SHPO Bank Barn North and West Elevations, view sathrast Photo 11 of 17 HO-0563_2009-12-22_11:tif

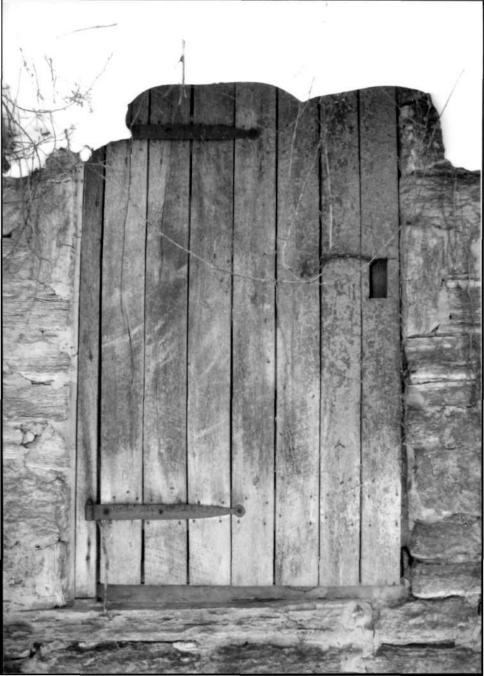
HO-563 Williams Hase Clarkenille vicinity Haverd Conty M. Blair Dec. 2009 MD SHPO Barn Door, viewsath Photo 12 of 17 HO-0563_2009-12-22 11.tif

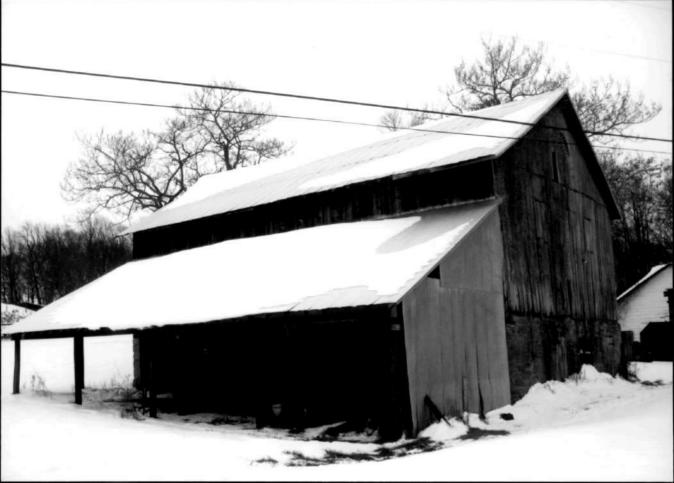
HO-563 Williams House arkaille vicinity Harard Conty M. Blair Dec. 2009 MD SHPO Bank Born East and North Elevations, Wen southwest Photo 13 of 17 40-0563_2009-12-27_13. Tit

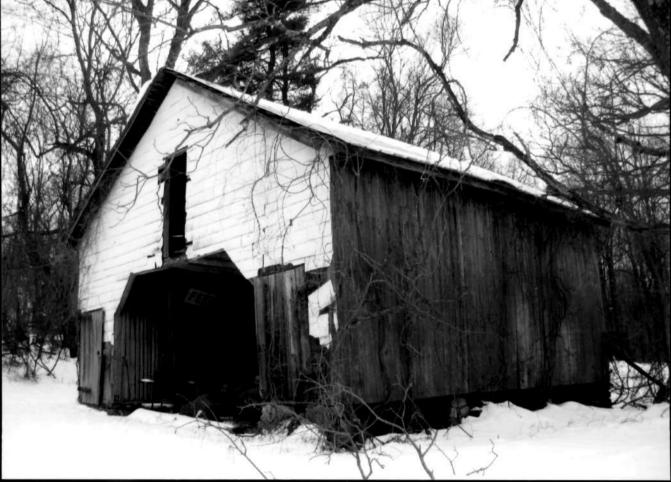
HO-563 Williams Hase Clarksulle vicinity Howard Courty M. Blair Dec. 2009 MD SHPO Corn Crib, view sathwest Photo 14 of 17 HO-0563_ ZOO9-12-ZZ_ 14. HF

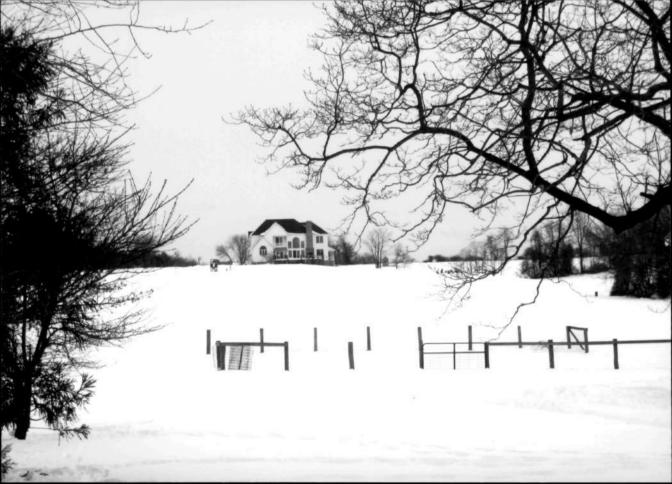
HO-563 Williams Hase Clarkeville vicinity Havard Centy M. Blair Dec. 2009 MD SHRO Viewshed from House, view sath Photo 15 of 17 HO-0563_2009-12-22_15.tif

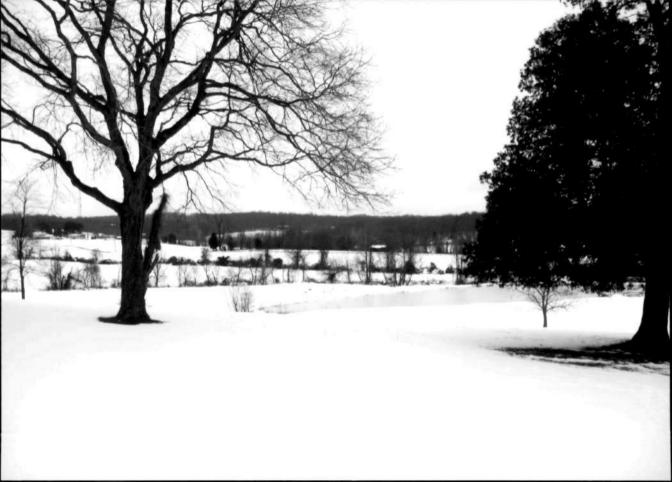
HO-563 Williams House Clarks ville licinity Haverl Courty M. Blair Dec. 2009 MD SHPO Viewshed from Hase, view north Photo 16 of 17 HO-0563_2009-12-22_16.tif

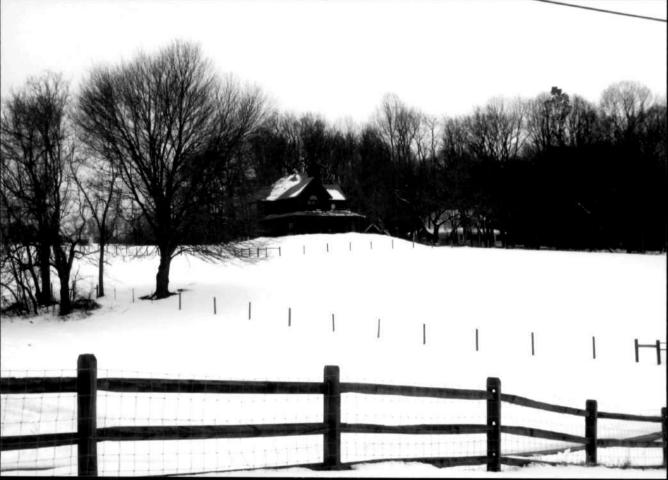
HU-563 Williams House Clarksville vicinity Howard County M. Blair Dec 2009 MD SHPO Modern House on Property, view southwest Photo 17 of 17 HO-0563_2009-12-22_17.tif
